PACSystems* RX3i

IC695CRU320

Redundancy CPU

GFK-2514F
August 2010

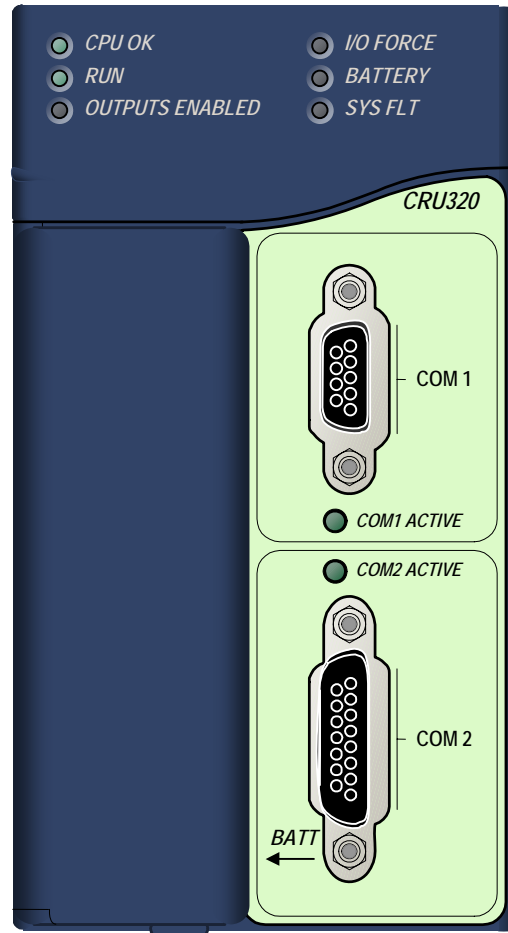
The PACSystems* RX3i Redundancy CPU can be used to perform real time processing and discrete automation for various applications. The CPU communicates with the programmer and HMI devices via serial SNP Slave protocol. It communicates with I/O and smart option modules over a dual backplane bus that provides:

- High-speed PCI backplane for fast throughput of advanced I/O.
- Serial backplane for easy migration of existing Series 90-30 I/O.

- In-system upgradeable firmware.
- Two serial ports: an RS-485 serial port and an RS-232 serial port.
- Ethernet communications via the rack-based Ethernet Interface module (IC695ETM001). For details, refer to *TCP/IP Ethernet Communications for PACSystems User's Manual*, GFK-2224.
