MG2400 series, MG2500 series Technical Reference

(MG2440, MG2450, MG2540, MG2550)

QY8-2349-000

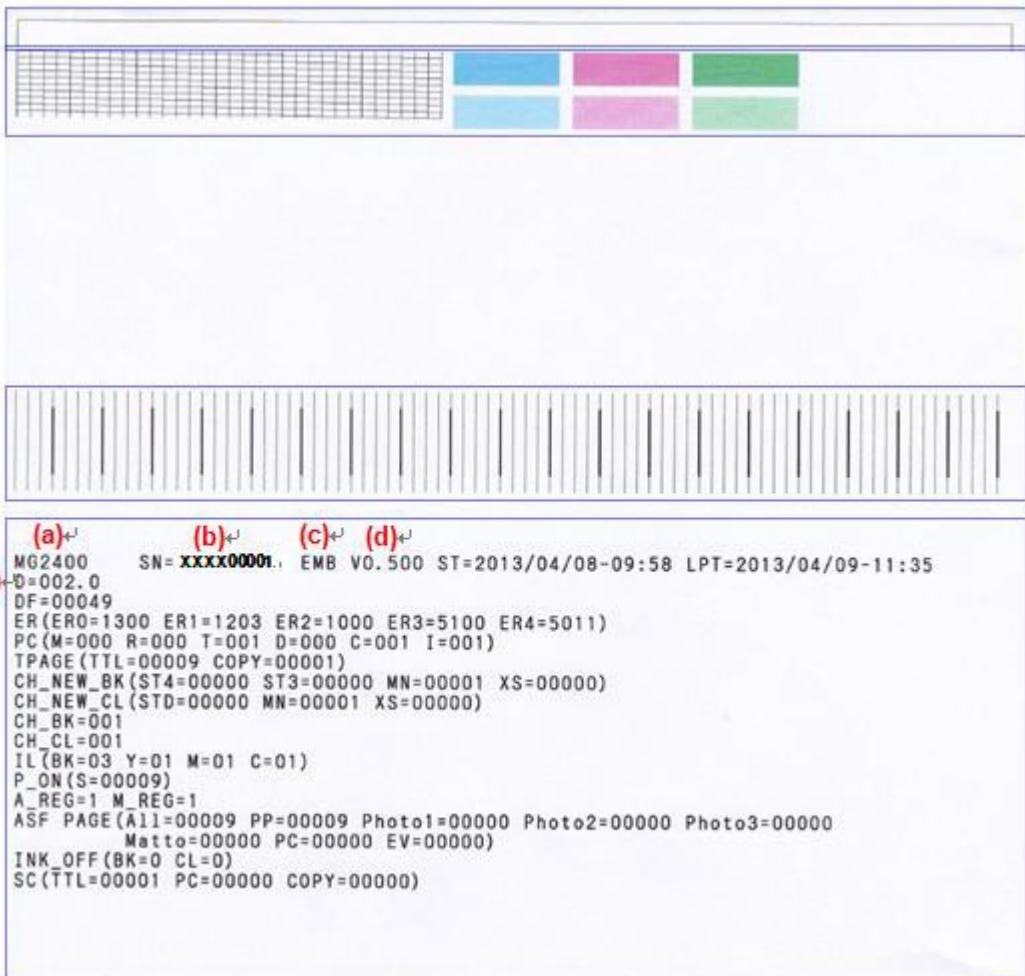
3) Service test print sample (MG2400 series)

On the service test print (sample below), confirm the following items:

- Check 1: Top of form accuracy, skewed paper feeding, left margin, and carriage (outermost) accuracy
- Check 2: Nozzle Check Pattern print (Ink must be ejected from all nozzles.)
- Check 3: Straight line accuracy (There must be no remarkable dot mis-alignment on a line.)
- Check 4: EEPROM information

The image shows a service test print for an MG2400 series printer. It is divided into several sections for inspection:

- Check 1:** Top of form accuracy, skewed paper feeding, left margin, and carriage (outermost) accuracy.
- Check 2:** Nozzle Check Pattern print (Ink must be ejected from all nozzles.).
- Check 3:** Straight line accuracy (There must be no remarkable dot mis-alignment on a line.).
- Check 4:** EEPROM information.

The EEPROM information is printed as follows:

```
(a) MG2400 (b) SN=xxxx00001 (c) EMB V0.500 (d) ST=2013/04/08-09:58 LPT=2013/04/09-11:35
(e) D=002.0
DF=00049
ER(ER0=1300 ER1=1203 ER2=1000 ER3=5100 ER4=5011)
PC(M=000 R=000 T=001 D=000 C=001 I=001)
TPAGE(TTL=00009 COPY=00001)
CH_NEW_BK(ST4=00000 ST3=00000 MN=00001 XS=00000)
CH_NEW_CL(STD=00000 MN=00001 XS=00000)
CH_BK=001
CH_CL=001
IL(BK=03 Y=01 M=01 C=01)
P_ON(S=00009)
A_REG=1 M_REG=1
ASF_PAGE(All=00009 PP=00009 Photo1=00000 Photo2=00000 Photo3=00000
Matto=00000 PC=00000 EV=00000)
INK_OFF(BK=0 CL=0)
SC(TTL=00001 PC=00000 COPY=00000)
```

On the Service Test Print (sample below), confirm the EEPROM information.

- Bottom area (Check 4 area):

- (a) Model name
- (b) Printer serial number (4 digits of alphabets + 5 digits of number)
- (c) Destination
- (d) ROM version (V#.###)
- (e) Main ink absorber counter value (D=###.#)

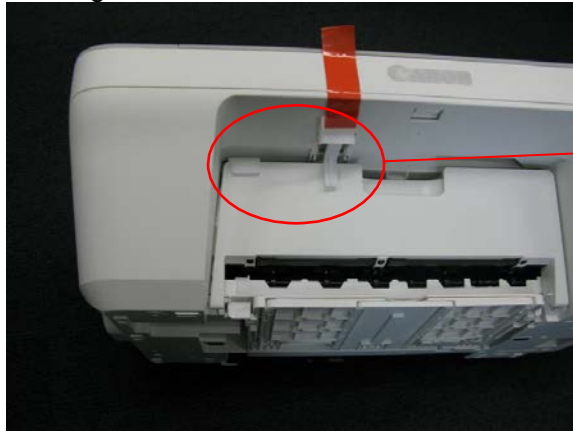
Packing material attached to the machine:

Packing Material to fix the carriage
